VOLVO OCEAN RACE INDEPENDENT REPORT INTO OCEAN RACING AT NIGHT IN AREAS OF HIGH VESSEL TRAFFIC DENSITY

The Volvo High Traffic Density Report

Chris Oxenbould, Stan Honey and Chuck Hawley
17 September 2018

Final

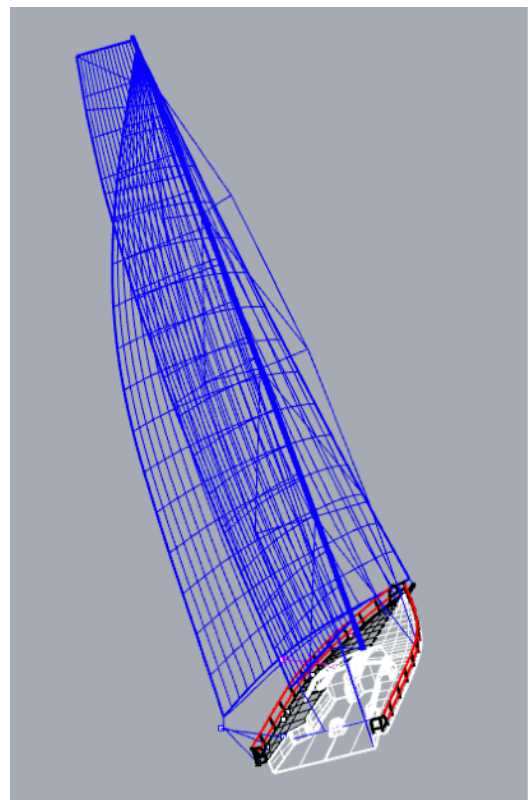
62. All crews were acutely aware of the problem created by the sail plan and the ability to maintain a good lookout on the lee bow⁵. Depending upon which headsails were set there could be an arc of about 90° from the helmsman's position that would be blanked out - from a few degrees on the lee bow to abeam on the lee side. The crews applied themselves diligently to overcome the problem.
63. The A3 Gennaker (A3) and Masthead Code 0 (MH0) cause the most difficulty when running or reaching; being set from the end of the bowsprit, with a low foot and

Figure 5 - A rendering of the sail plan of a VO 65 - with a full main and a MH0 sheeted through the aft outrigger

sheeted well aft nearly adjacent to the helmsman. The use of an outrigger⁶ to sheet the sails further outboard can increase the forward looking blind arc. The situation is further aggravated for a large portion of the time racing, when the boat is being pressed hard on a reach and sailing on a large angle of heel at about 30°; the boom and mainsail can also restrict the line of sight to leeward.

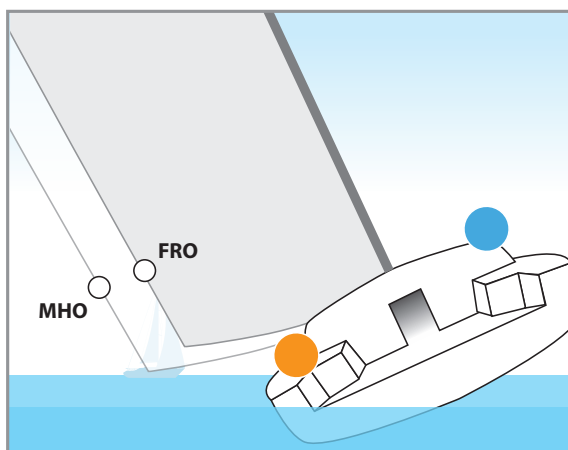
Figure 8 -Depiction of the look-out from the cockpit - Blue dot the Helmsman - Orange dot the leeward lookout - Different arcs of visibility with MHO and FRO

65. Crews developed techniques that varied slightly between boats. The helmsman has the best view, positioned high on the windward side and looking ahead with a clear view to windward and the ability to see past the headsail's luff for a few degrees on the lee bow. Other crew on deck can watch to leeward and astern.

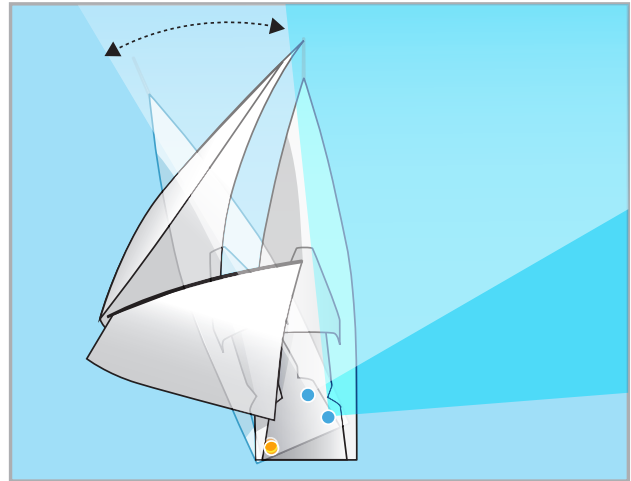
Figure 11 - 'Dipping' the bow to leeward by 20° demonstrating the increased look-out to leeward available to the helmsman

153. In some conditions there will be a residual blind arc of about 20°-30° that may be able to be viewed by 'dipping the bow' up to 30° to leeward for the helmsman to gain a view. The dip frequency would need to be adjusted depending on the four

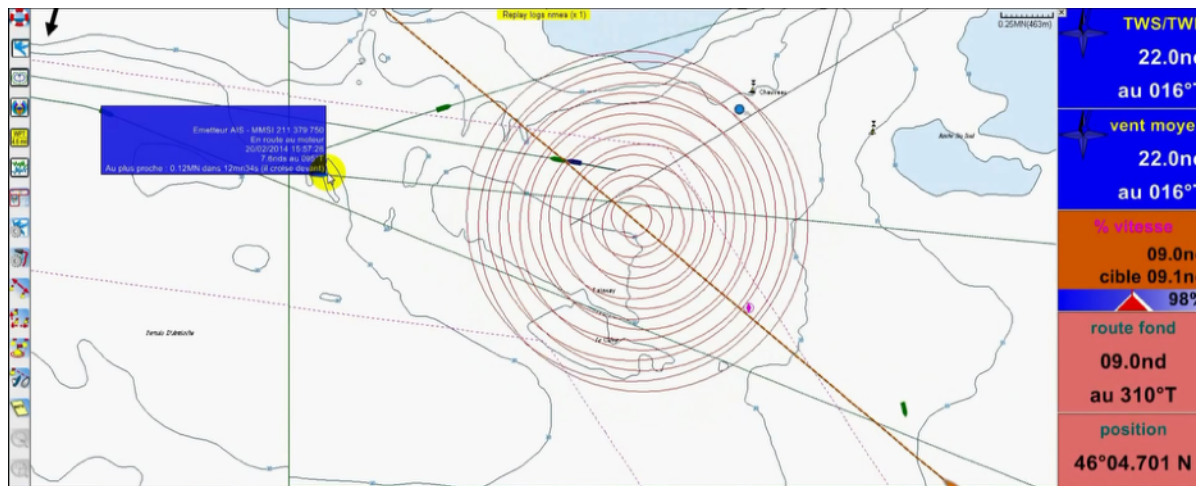
Figure 12 - Adrena presentation - the Blue text box (top left) includes - At the nearest 0.12nm in 12 min 34 sec (he crosses ahead) - the CPA information

92. When interviewing the crews, the Adrena AIS interface was reported as easier to use than Expedition. Adrena's AIS display specifies whether the closest point of approach (CPA) has the other vessel passing ahead or astern of your own vessel. This provides a simple interpretation of which way to turn to increase the CPA. Adrena's AIS display was reported to become complicated and difficult to use in dense traffic environments.

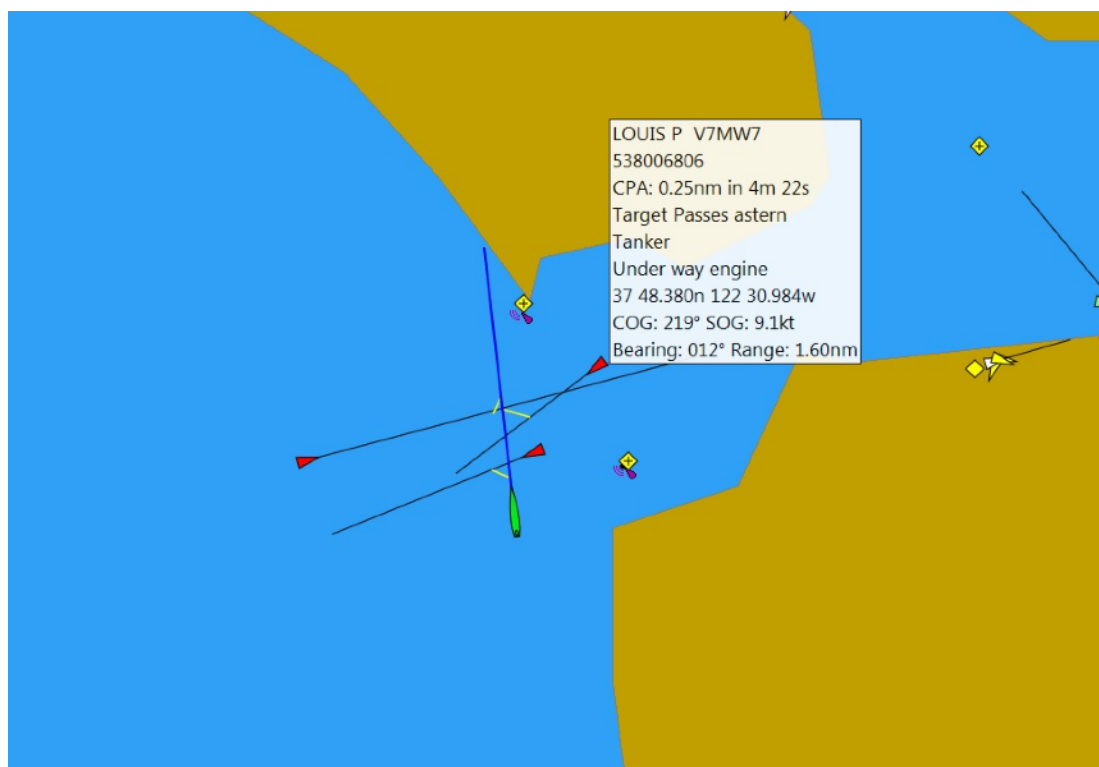
95. The first involves interpreting the speed leaders from the test vessel and a contact. By observing the intersection of the test vessel's track and that of the *Louis P*, we can observe that it is about 60% along the *Louis P*'s predictor line and the 60% point on the test vessel predictor line is well beyond the intersection point. This means the *Louis P* will pass astern. This is a popular means of working out a CPA but is not a precise measurement and prone to error if the operator is tired and faced with a congested screen.

Figure 13- Expedition Presentation - Test vessel is green in centre of screen heading north - contact of interest Louis P is to the north east exiting the strait

96. The second method uses the yellow line, which is drawn at the predicted time of the CPA, from the test vessel to the *Louis P*'s position at the time of CPA. At the CPA *Louis P* is abaft the test vessel's beam and crossing astern. This approach seems to be the clearest for close CPA's. As the CPA gets smaller and more dangerous, the yellow line gets shorter until for a CPA of 0 the yellow line disappears.

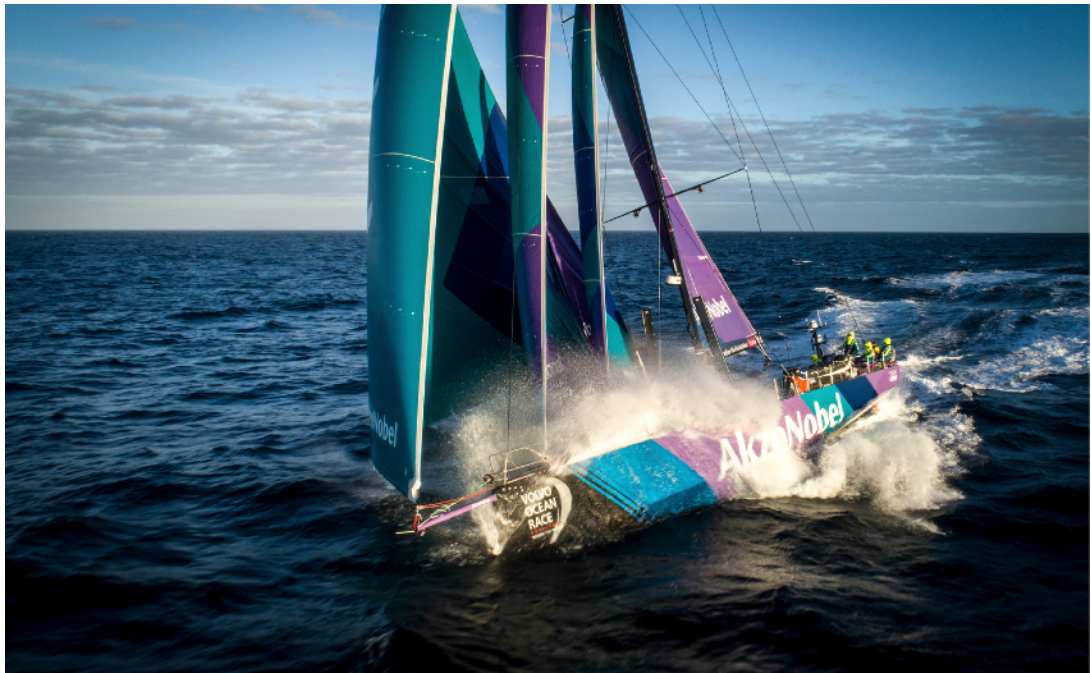
101. The radar antenna is sited on the forward face of the mast at a height of about 6 metres, which is below the first spreaders. The signal is attenuated and the receiver noise floor is increased by the loss and reflection from the headsails. This is more pronounced when the sails are wet and results in poor radar coverage in the critical area of the lee bow where the visual look-out is also degraded. Radar detections often follow an initial visual sighting.

Figure 14- Akzonobel with the radar antenna visible on the mast just above the top of the daggerboards - the steaming light can be seen on the mast just above the spreaders

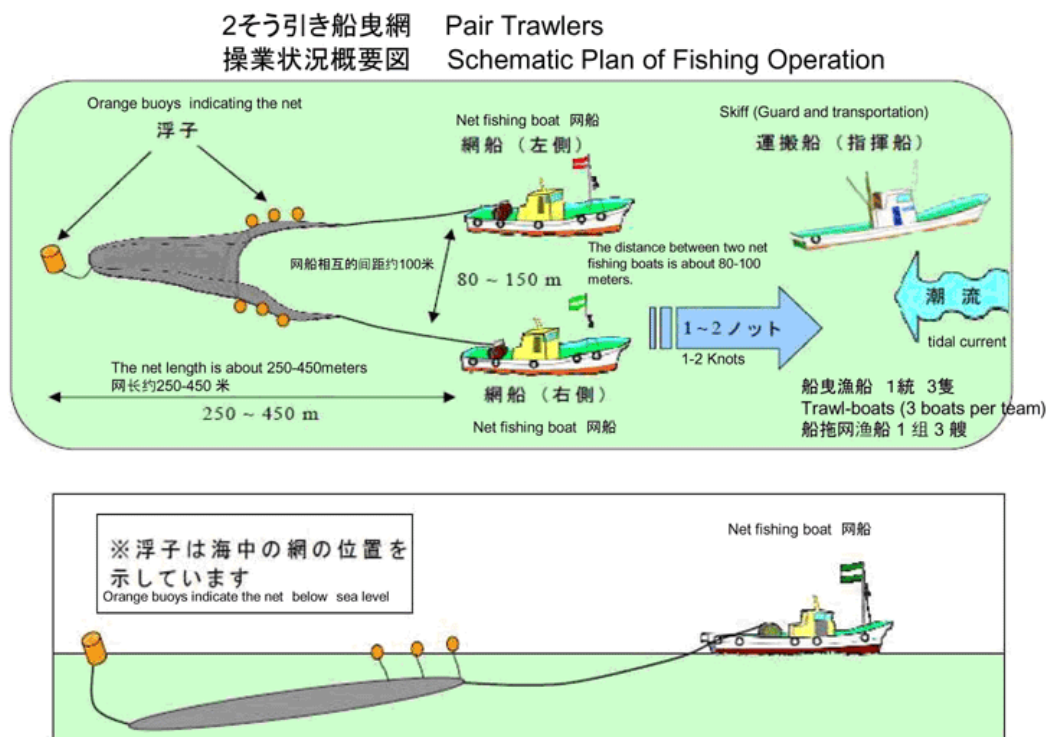
Figure 15 - Pair Trawling

134. Those engaged in pair-trawling can have a similar hazard distance, and have been encountered over 400m apart - greater than indicated in the diagram at Figure 15. The distance between trawlers can be scaled upwards when larger vessels are operating. Pair-trawling nets are particularly difficult to detect as they are barely visible, they are moving and the fishing vessels can be a long way from the nets.

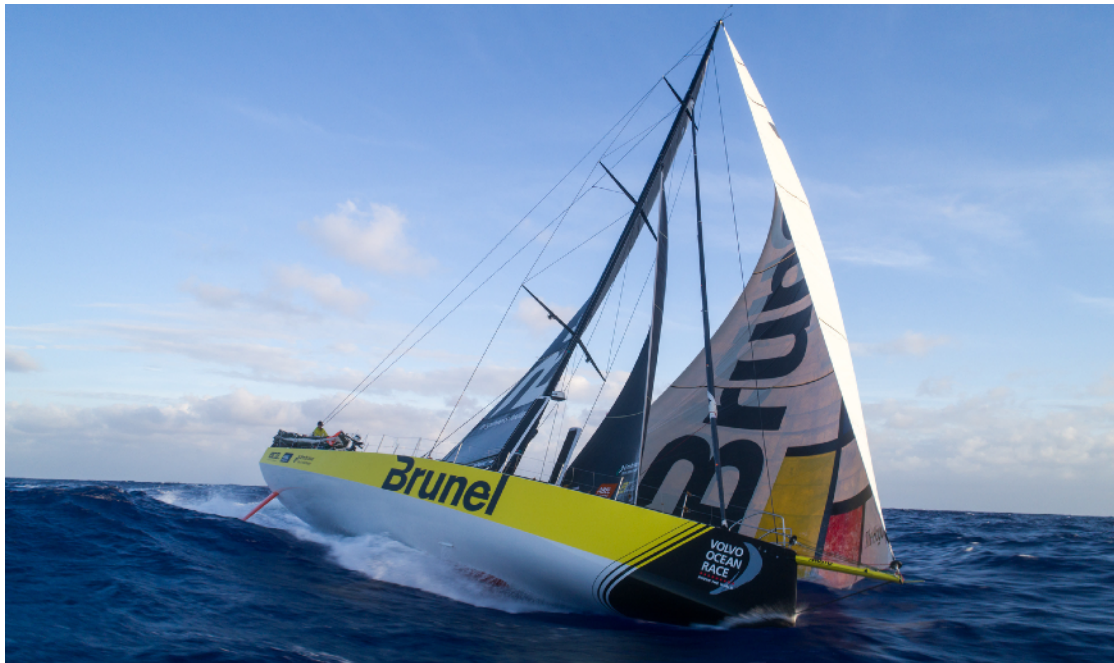
*Figure 16 - The problem the look-out on the lee bow
Credit: Sam Greenfield/Volvo Ocean Race*

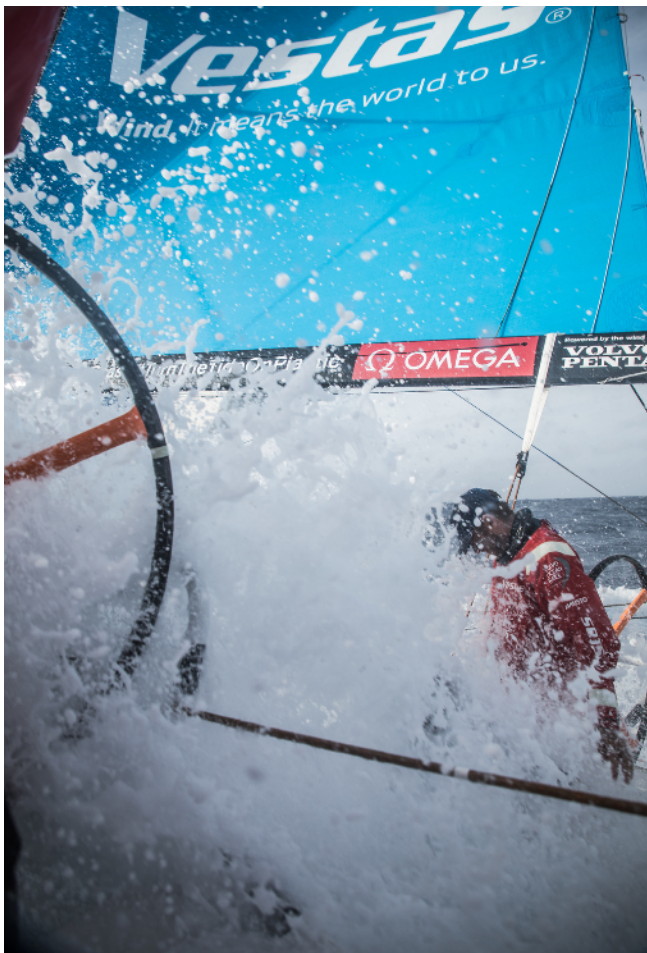
Figure 17 - The challenge for a leeward look-out
Credit: Martin Keruzore/Volvo Ocean Race

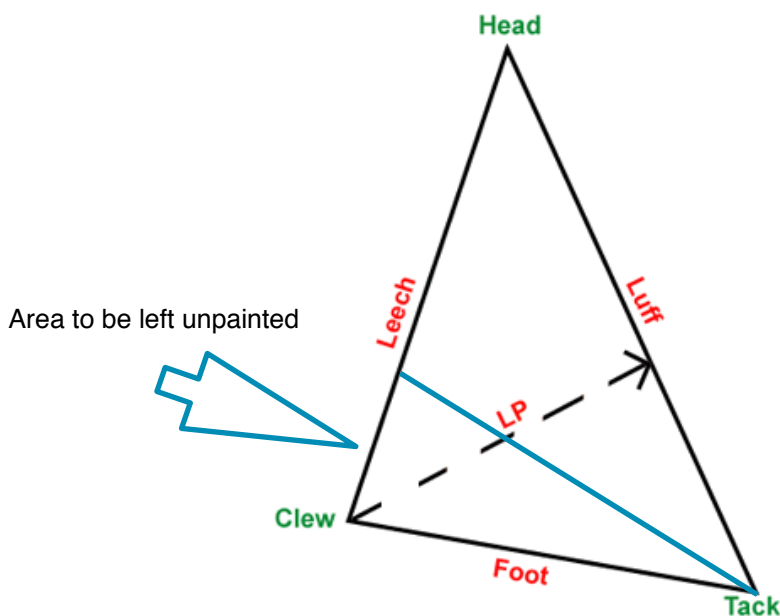
178. In an attempt to resolve the look-out blanking problem created by the headsails, suggestions were received proposing clear panels being placed in the headsails as are often used in other classes that have a similar look-out problem.

Figure 22 - Named parts of a headsail - with the marked area considered to be left unpainted

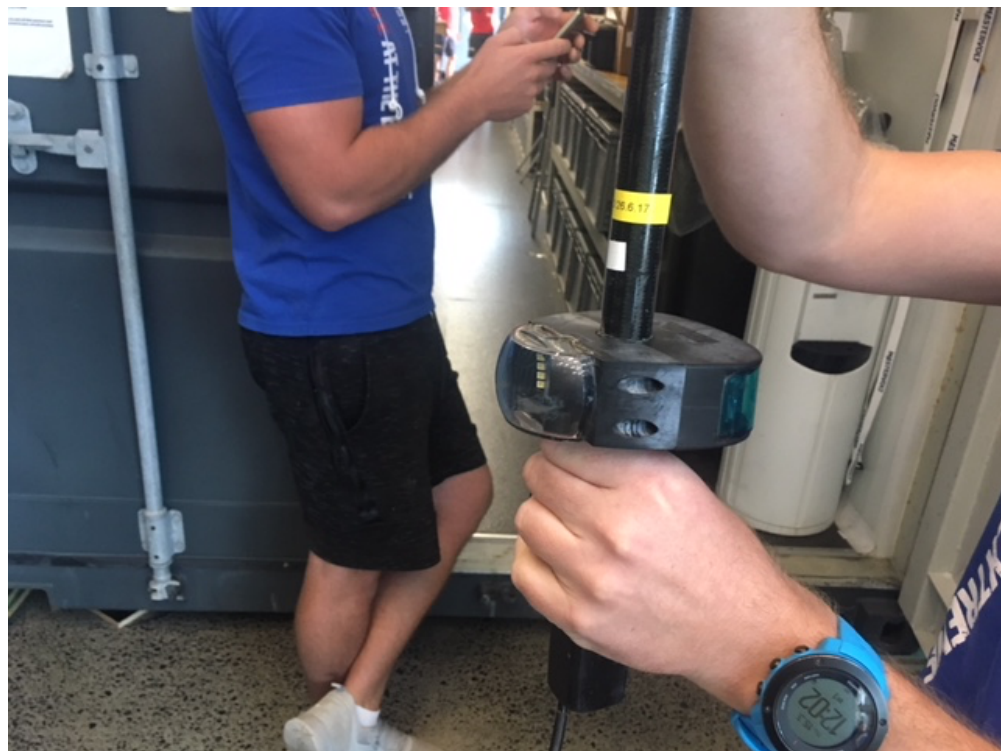
190. The three lights fitted at the masthead are separate Hella light fixtures with their own LED globes. They differ from the 'combined into one lantern' that is permitted in IRPCAS Rule 25 but restricted to a sailing vessel of less than 20m in length. The combined lantern is assumed to have been a means of minimising power consumption

Figure 23 - VO 65 Navigation Light fitting clamped on to the vertical masthead unit that is fitted to the top of the mast - viewed from the starboard quarter, showing the sternlight and starboard sidelight

208. The report team considers that VO 65s should be fitted with a second set of sidelights and a sternlight near deck level to enhance the presence of the boat at night in areas of high vessel traffic density and in harbour. The additional lights could be used, at the discretion of the PIC, in conjunction with the lights at the masthead, whenever warranted by the prevailing circumstances.
