VOLVO OCEAN RACE INDEPENDENT REPORT INTO OCEAN RACING AT NIGHT IN AREAS OF HIGH VESSEL TRAFFIC DENSITY

The Volvo High Traffic Density Report

Chris Oxenbould, Stan Honey and Chuck Hawley
17 September 2018

Final

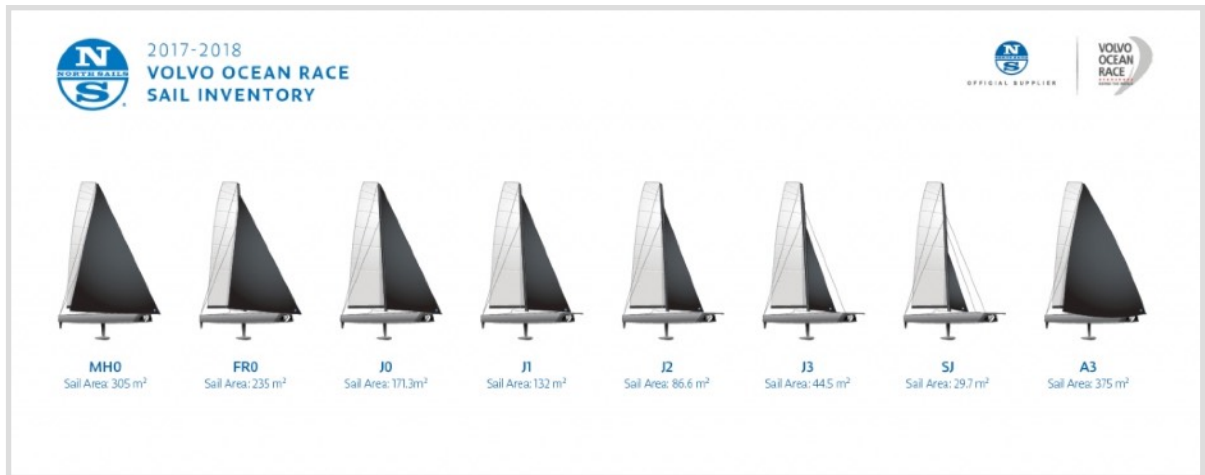
62. All crews were acutely aware of the problem created by the sail plan and the ability to maintain a good lookout on the lee bow⁵. Depending upon which headsails were set there could be an arc of about 90° from the helmsman's position that would be blanked out - from a few degrees on the lee bow to abeam on the lee side. The crews applied themselves diligently to overcome the problem.
63. The A3 Gennaker (A3) and Masthead Code 0 (MH0) cause the most difficulty when running or reaching; being set from the end of the bowsprit, with a low foot and

sheeted well aft nearly adjacent to the helmsman. The use of an outrigger⁶ to sheet the sails further outboard can increase the forward looking blind arc. The situation is further aggravated for a large portion of the time racing, when the boat is being pressed hard on a reach and sailing on a large angle of heel at about 30°; the boom and mainsail can also restrict the line of sight to leeward.

Figure 6 - The VO 65 headsail sail plan

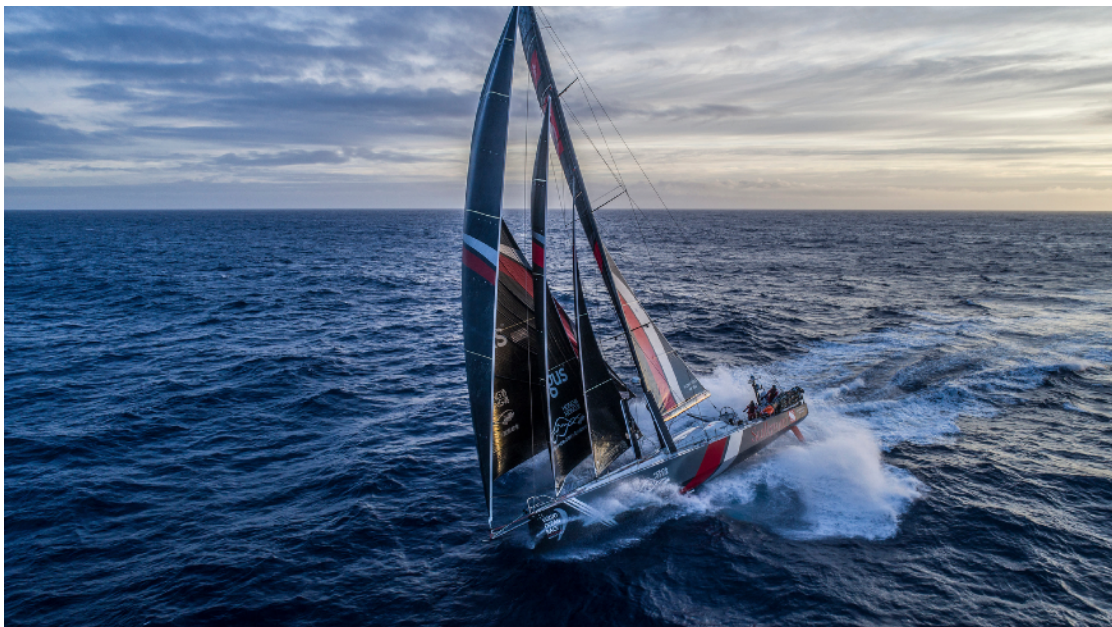
Figure 7 - Sun Hung Kai/Scallywag sailing with a triple headsail rig - MHO, J2 and J3 - the MHO is sheeted through a outrigger
Credit: Konrad Frost / Volvo Ocean Race

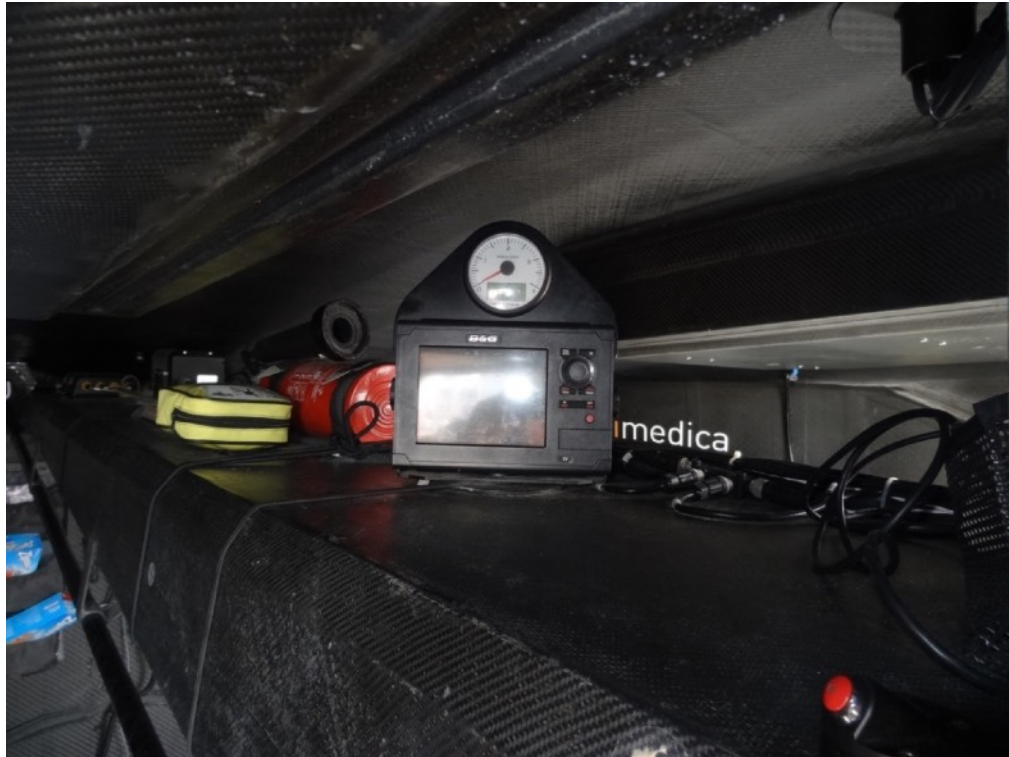
*Figure 18 - Photo of the ‘tunnel’ MFD just inside the cabin available to the crew on deck
Credit: Photo by Chuck Hawley 2014*

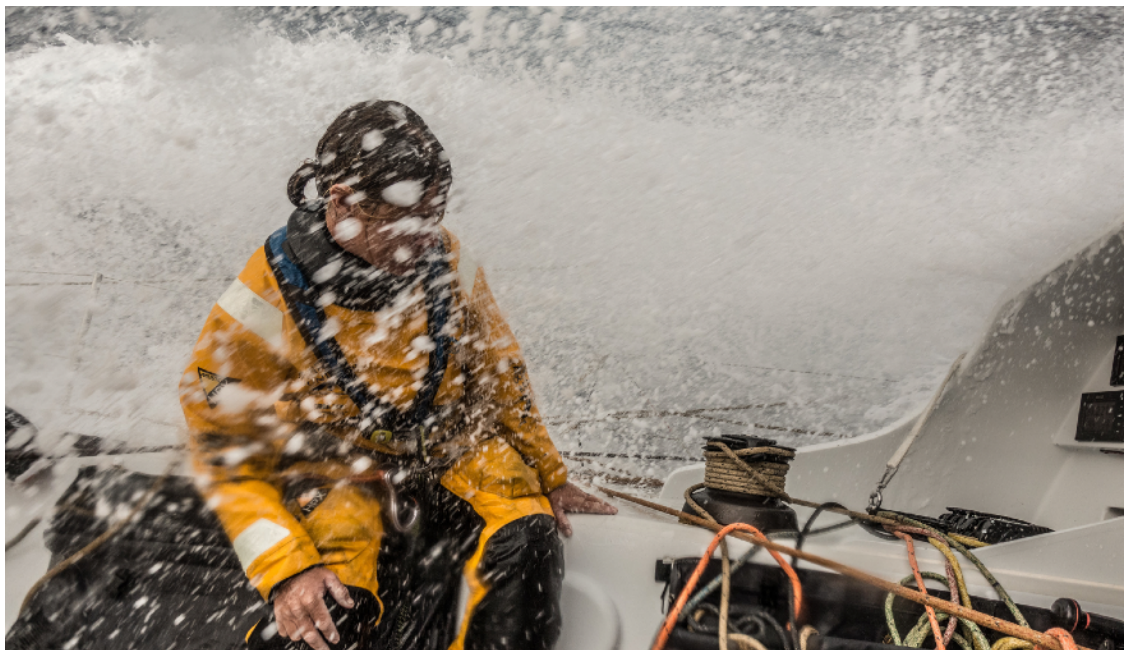
Figure 24 - Life as a leeward look-out on Turn the Tide on Plastic
Credit: James Blake/Volvo Ocean Race
